Relay's Event Reports Offer Powerful Data for Diagnosing Power System Problems

*Ed Sullivan and John C. Elliott
Power PR*

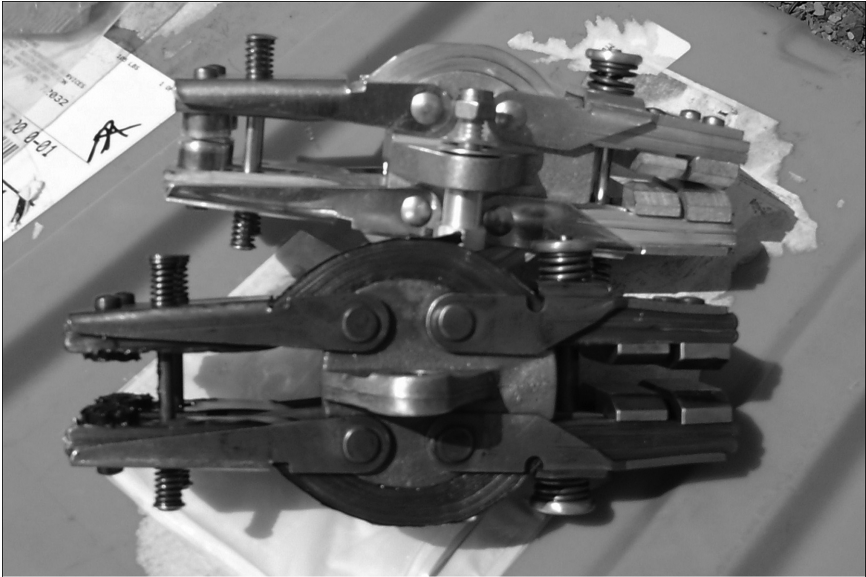
Figure 1. Bridge Contact Photo

Perry said the event records showed a decrease in C-phase current (IC) and C-phase voltage (VC), while A-phase and B-phase currents increased. "This occurred on two feeders. I suggested testing their transformer, which was a tap changer. When we inspected it, we found that the rotary tap changer contacts were severely worn." (See Figure 1.)

The old bridge contact is shown in the lower portion of this on-site photo. The contacts at both ends are severely worn. The new bridge contact at the top of the photo clearly shows what the contacts should look like.

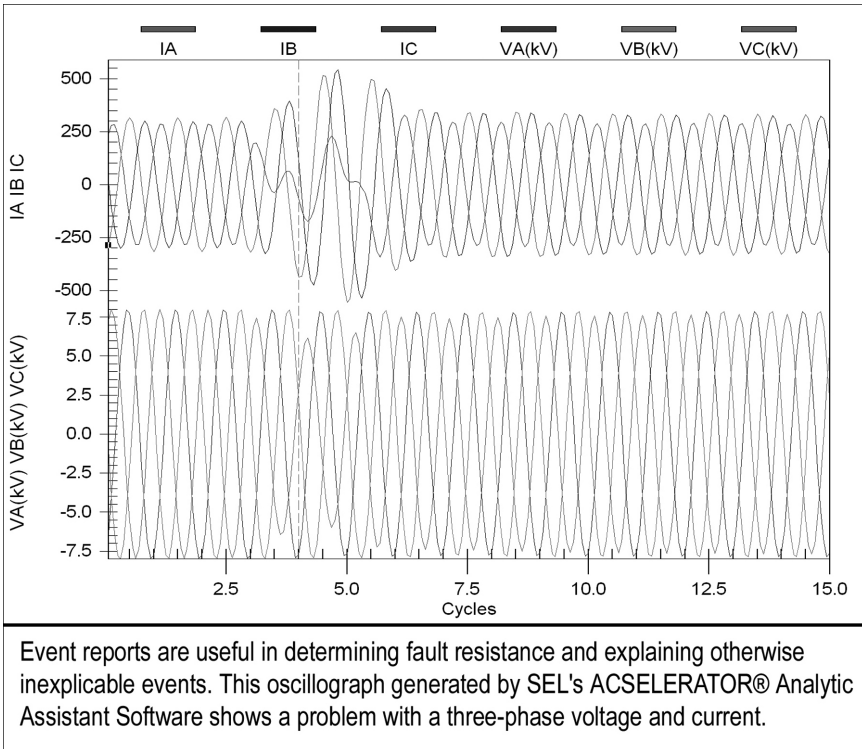
Figure 2. Event Report Oscillograph

"What was causing the problem was that the C-phase on the utility transformer was opening up, and the industrial customer was in single phase," he added. "It wasn't a complete opening; actually, the moving contacts in the transformer were arcing. That's why the event report oscillograph (Figure 2) showed the collapsed C-phase voltage and the collapsed C-phase current, just as if you were removing the voltage off of the load C-phase. There was a three-phase system within the industrial facility that was actually single phasing, which could cause equipment damage. And of course, the arcing of the transformer caused damage to the contacts."
