Turning Capital Projects Into Energy Projects

*Rafael M. Negron, CEM BEP,
Principal
NORGEN Consulting Group, Inc.*

BUILDING DESCRIPTION

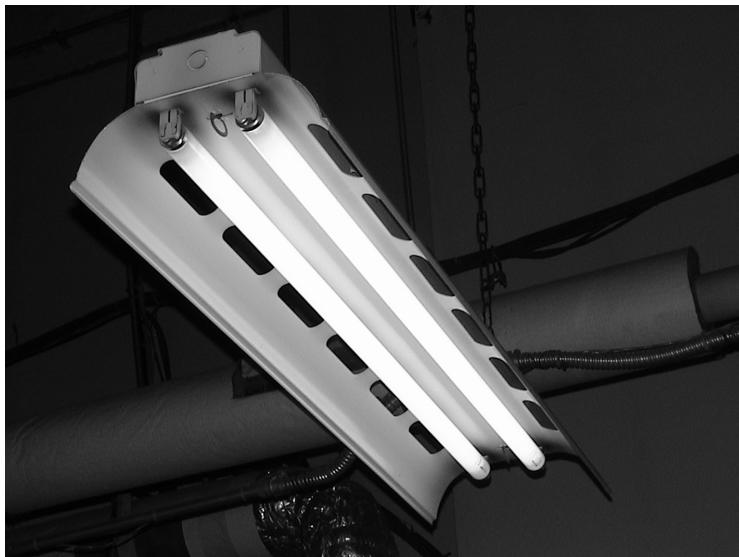
Figure 1. Typical Light Fixture

The audit revealed that the space had T12 fluorescent lamps with magnetic ballast. For the most part, the lighting was controlled with wall switches distributed throughout the offices. Some floors had occupancy sensors installed in individual offices. The lighting in the MERs and the data center was also T12 fixtures, typically operated 24 hours a day, 7 days a week. A typical MER lighting fixture is shown in Figure 1.

- Replace all of the lighting with T8 lamps and electronic ballasts, compact fluorescent lamps, and occupancy sensors;
- Install high efficiency 50-ton units instead of 70 ton units;
- Install a BMS system in lieu of duct cleaning;
- Install variable frequency drives on the condenser water pumps instead of using the turn down valves;
- Complete a full scale retro-commissioning of the supply and return air ducts prior to installing the new systems;
- Install digitally controlled VAV boxes instead of pneumatically controlled boxes;
- Tie VAV boxes and air conditioning units to the BMS;
- Set up energy savings routines like night set-back, smart start / stop, and economizer cycles.

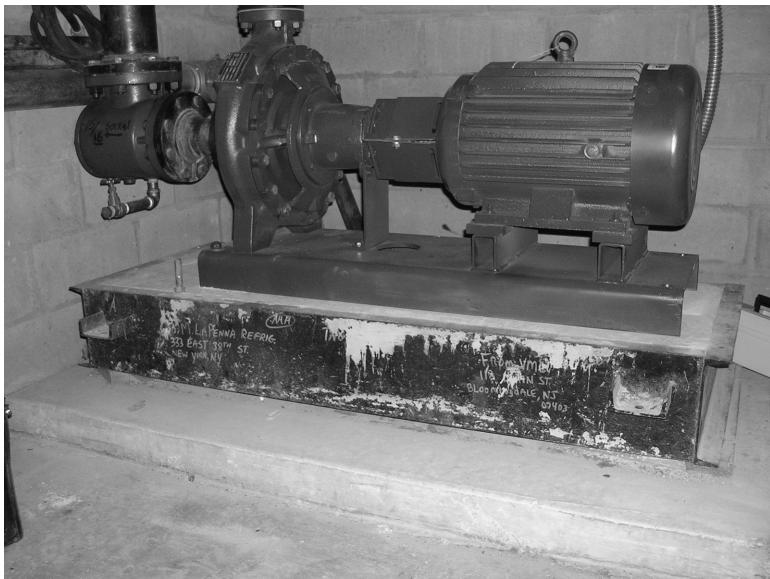
Figure 2. Typical Condenser Pump

Each floor had a 20-hp condenser water pump that moved water to the cooling tower above the 11th floor. The 10th floor MER had a 10-hp pump for the 11th floor air conditioning unit. The audit revealed that the 20-hp sizing was based on the 2nd floor requirement. Turn-down valves were used to balance the condenser water flow with the air conditioners. A typical condenser pump installation is seen in Figure 2.

Subsequent measurement and verification activities demonstrate that the VFDs are saving nearly double the original estimate, or 100,000 kWh per year. Once installed, the VFD was used to reduce the motor speed to balance the condenser water flow. Once balanced, the VFD setting was left in place. Figure 8 shows a condenser pump with the VFD in place.

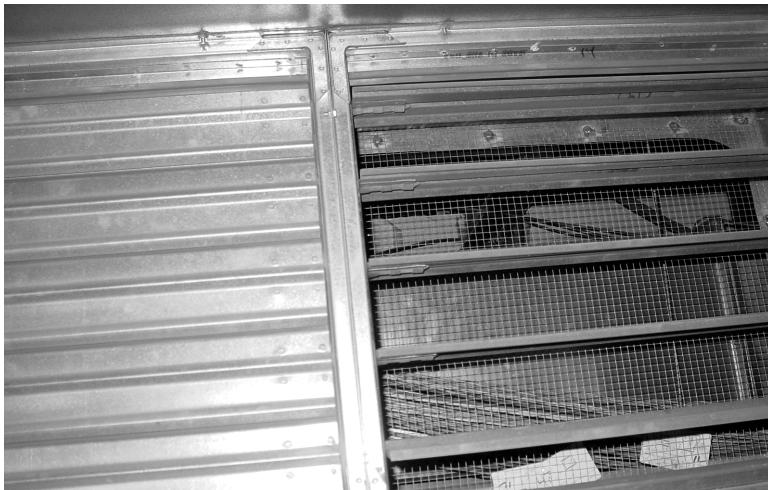
Figure 3. Return Air Damper

into the MERs was restricted and resulted in significant negative pressures in most rooms. In addition, some return air dampers were not working properly and had broken linkages. Figures 3 and 4 show some of the damage identified.

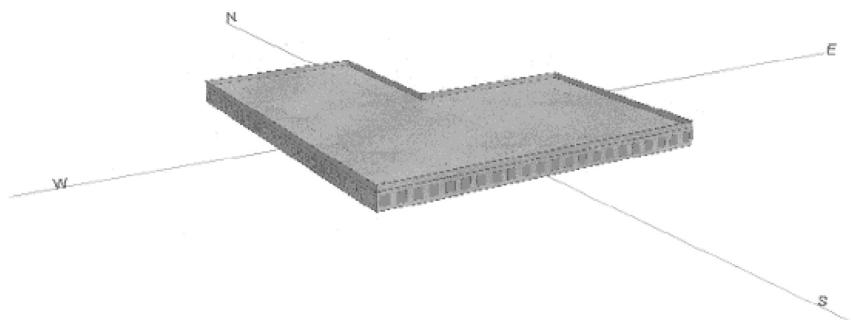
Figure 5. eQuest Model Output

To confirm the sizing of the air conditioning units, a computer model was constructed for each floor using eQuest 3.44. The model was constructed based on floor plans for the building and data collected during the audit for occupancy, hours of operation, and lighting load [1]. The graphical output for one of the middle floors is shown in Figure 5, and the results of the energy model are shown in Table 1.

The energy model suggested that the capacity of the existing ACs was more than adequate to provide cooling for the space. The peak cooling load for the 10th floor, the floor with the most outside exposure,

was 71 tons out of the existing 100 tons. Installing two (2) 70-ton units per floor would have significantly exceeded the spaces' cooling requirements.

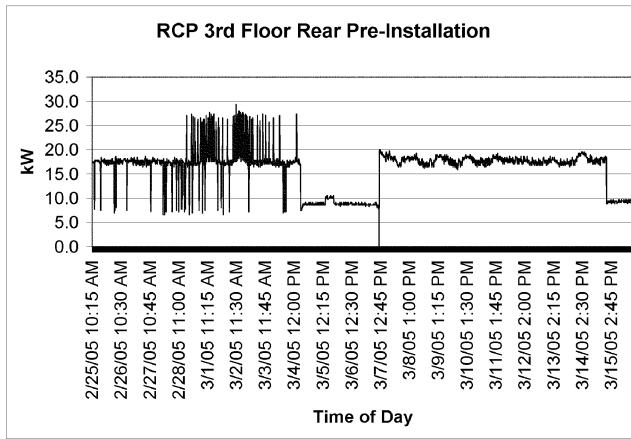
Figure 6. Baseline Operating Profile for AC

By installing the BMS in lieu of duct cleaning, the client was able to reduce its operating costs by nearly \$150,000 and provide the operator a way to operate and monitor the systems from one location. A large part of the energy savings resulted from controlling and monitoring the AC units remotely, instead of relying on local controls. Figure 6 shows the operating profile of the 3rd floor AC unit before the installation of the BMS, where the unit ran most of the time (irrespective of occupancy or need). This operating profile was typical for most of the units in the space. Figure 7 shows the operating profile of the new 3rd floor unit after installation of the BMS, and shows that the unit only operates weekdays during typical office hours.
